# Manhole Inspection Summary

Manhole # S45EE\_024MH

Insp Date: **3/11/08 12:32 PM**

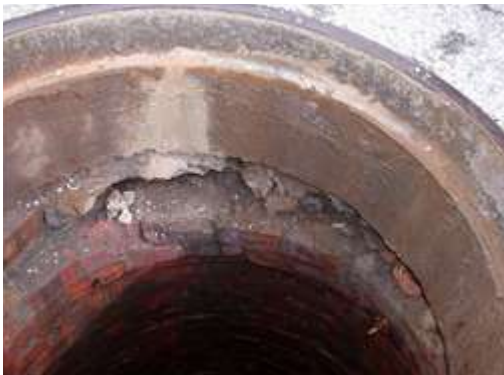
Defect 2

**Frame** Offset: **4** (in.) Condition: ☐ Sound ☐ Cracked ☒ **Leaks**

offset

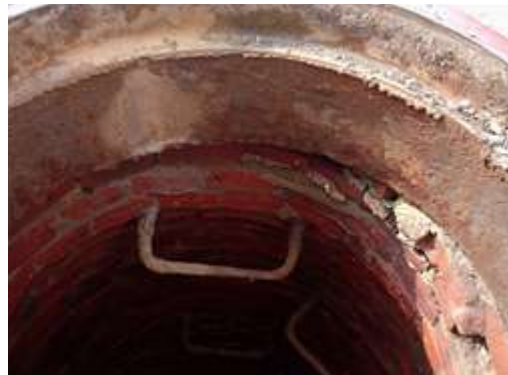
Defect 1

Condition: ☐ Sound ☐ Cracked ☐ Root Intrusion ☒ **Loose Brick** ☐ Deteriorated

Infiltration: ☐ None ☐ Joint ☐ Cracks ☒ **Mortar** ☐ Roots ☒ **Wall**

loose bricks

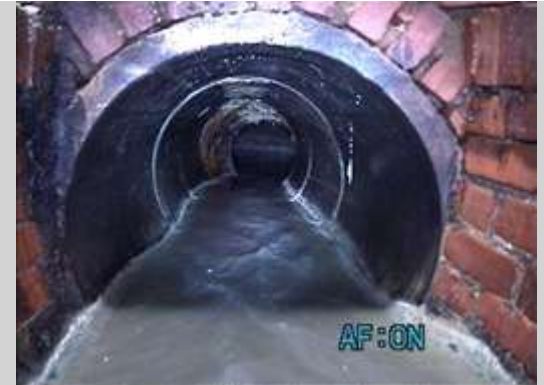
12 O'Clock Outflow

21 in. Circular Gravity Sewer  
Pipe Out @ 12 O'Clock

Pipe Height: **21.6** (in.) Rod and Bar (Angled)  
Pipe Material: **Clay** ☐ Pipe Lined  
Invert Depth: **11.75** (ft.) Flow Characteristics: **Fast**  
Deposits: ☒ None ☐ Mud ☐ Sludge ☐ Debris ☐ Grease  
Silt Depth: (in.) Deposits Extent:  
Infiltration: **None** Pipe Seal Cond: **Sound**

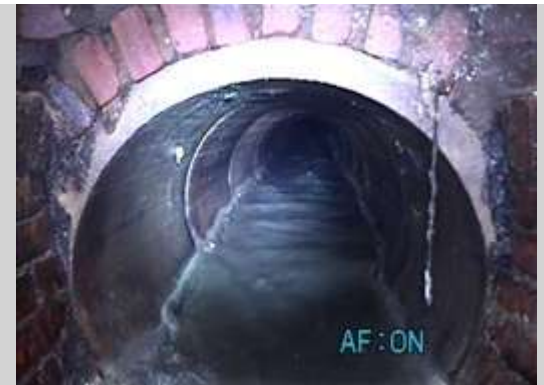
7 O'Clock Inflow

21 in. Circular Gravity Sewer  
Pipe In @ 7 O'Clock

Pipe Height: **21.6** (in.) Rod and Bar (Angled)  
Pipe Material: **Clay** ☐ Pipe Lined  
Invert Depth: **11.70** (ft.) Flow Characteristics: **Fast**  
Deposits: ☒ None ☐ Mud ☐ Sludge ☐ Debris ☐ Grease  
Silt Depth: (in.) Deposits Extent:  
Infiltration: **None** Pipe Seal Cond: **Sound**
